# Access Compliance Report Public Rights-of-Way (Curb Ramps)

Main Street: OLD\_RANCH\_RD Cross Street: BROOKHILL\_DR Location: SE

ADA ID: RPAT210922083619 Ramp Type: Type 3 - Combination 1 Initial Pass/Fail: Fail Overall Compliance: No Severity Score: 4

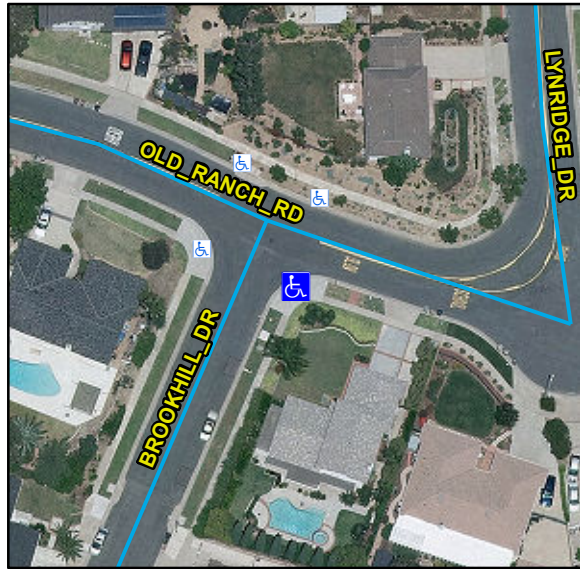
| Compliance | Description | Data | Compliance | Description | Data |
|---|---|---|---|---|---|
| No | Ramp Width LT (in) | 40 | No | Ramp Width RT (in) | 45 |
| N/A | Gutter Ponding | N/A | No | Curb Slope | 11.2 |

Remove & Replace Curb Ramp With Two New Directional Ramps or Equivalent. Remove & Replace Sidewalk.

R304.2.2, R304.5.1, STD 1115
