# Access Compliance Report Public Rights-of-Way (Curb Ramps)

Main Street: BROOKHILL\_DR Cross Street: OLD\_RANCH\_RD Location: W

ADA ID: RPAT210922084021 Ramp Type: Type 3 - Combination 1 Initial Pass/Fail: Fail Overall Compliance: No Severity Score: 5

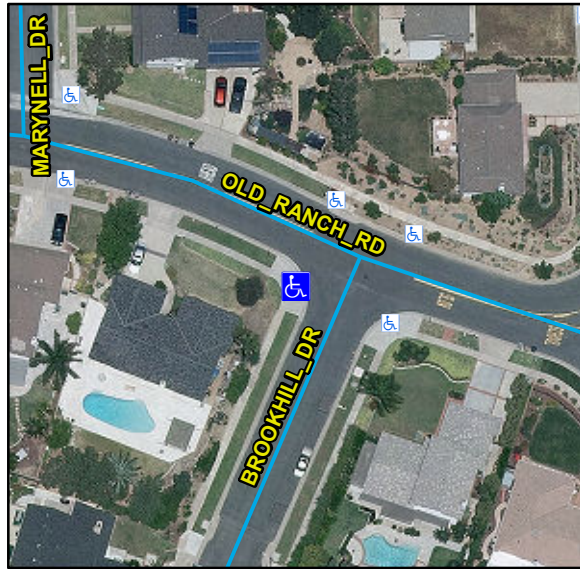
| Compliance | Description | Data | Compliance | Description | Data |
|---|---|---|---|---|---|
| Yes | Ramp Width LT (in) | 50 | No | Ramp Width RT (in) | 41 |
| N/A | Gutter Ponding | N/A | No | Curb Slope | 12.4 |

**Remove & Replace Curb Ramp With Two New Directional Ramps or Equivalent.**

**R304.2.2, R304.5.1, STD 1115**
