# Access Compliance Report Public Rights-of-Way (Curb Ramps)

Main Street: LYNRIDGE\_DR Cross Street: OLD\_RANCH\_RD Location: SW

ADA ID: RPAT210922084702 Ramp Type: Type 3 - Combination 1 Initial Pass/Fail: Fail Overall Compliance: No Severity Score: 16

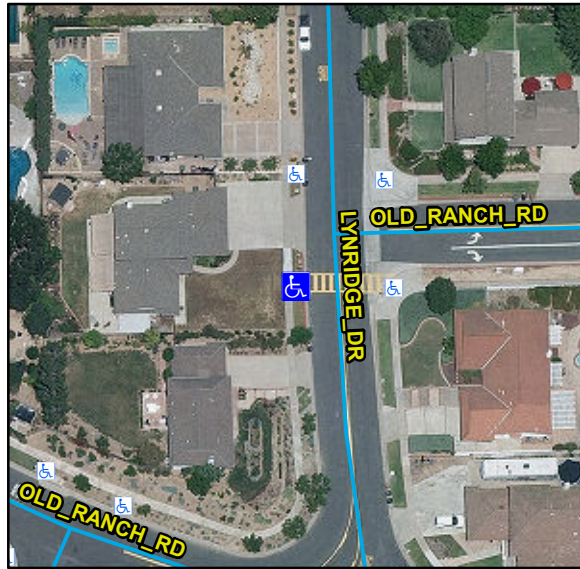
| Compliance | Description | Data | Compliance | Description | Data |
|---|---|---|---|---|---|
| No | Ramp Run Slope (%) | 8.4 | N/A | Flare Slope LT (%) | N/A |
| No | Ramp Cross Slope (%) | 2.6 | N/A | Flare Traversable LT | N/A |

Possible Solutions:

Remove & Replace Entire Ramp.
