# Access Compliance Report Public Rights-of-Way (Curb Ramps)

Main Street: **BROKEN\_HILL\_CT** Cross Street: **OLD\_RANCH\_RD** Location: **NE**

ADA ID: **RPAT210922085919** Ramp Type: **Type 3 - Combination 1** Initial Pass/Fail: **Fail** Overall Compliance: **No** Severity Score: **20**

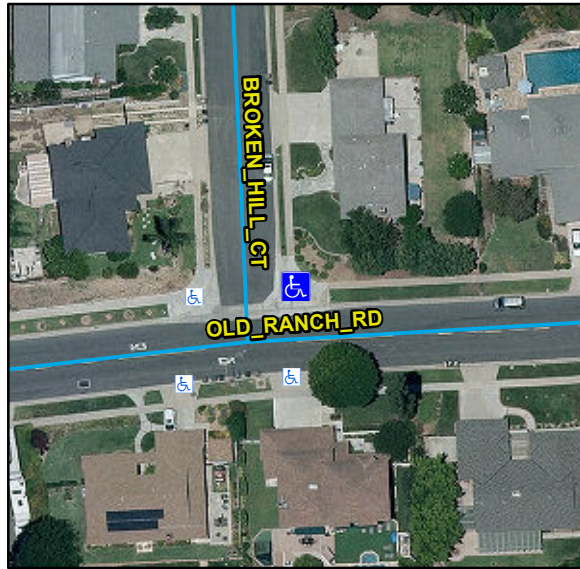
| Compliance | Description | Data | Compliance | Description | Data |
|---|---|---|---|---|---|
| <b>No</b> | Ramp Width LT (in) | <b>40</b> | <b>No</b> | Ramp Width RT (in) | <b>46</b> |
| <b>No</b> | Ramp Run Slope LT (%) | <b>11</b> | <b>Yes</b> | Ramp Run Slope RT (%) | <b>3.9</b> |
| <b>No</b> | Ramp Run Slope (%) | <b>8.6</b> | <b>N/A</b> | Flare Slope LT (%) | <b>N/A</b> |

**Remove & Replace Curb Ramp With Two New Directional Ramps or Equivalent.**

**R304.2.2, R304.5.1, R304.3.2, STD 1115**
