# Access Compliance Report Public Rights-of-Way (Curb Ramps)

Main Street: OLD\_RANCH\_RD Cross Street: BROKEN\_HILL\_CT Location: NW

ADA ID: RPAT210922090335 Ramp Type: Type 3 - Combination 1 Initial Pass/Fail: Fail Overall Compliance: No Severity Score: 64

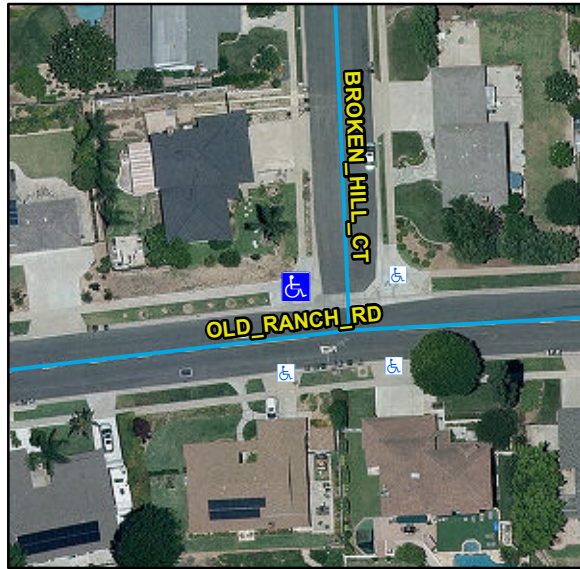
R304.2.2, R204.3, R304.5.1, R304.5.3, R304.3.2, STD 1115

| Compliance | Description | Data | Compliance | Description | Data |
|---|---|---|---|---|---|
| No | Ramp Width LT (in) | 44 | No | Ramp Width RT (in) | 38 |
| Yes | Ramp Run Slope LT (%) | 6.1 | No | Ramp Run Slope RT (%) | 17.1 |
| No | Ramp Cross Slope (%) | 7.3 | N/A | Flare Traversable LT | N/A |

Remove & Replace Curb Ramp With Two New Directional Ramps or Equivalent.
