# Access Compliance Report Public Rights-of-Way (Curb Ramps)

Main Street: OLD\_RANCH\_RD Cross Street: STONEHEDGE\_CT Location: NW

ADA ID: RPAT210922094449 Ramp Type: Type 3 - Combination 1 Initial Pass/Fail: Fail Overall Compliance: No Severity Score: 15

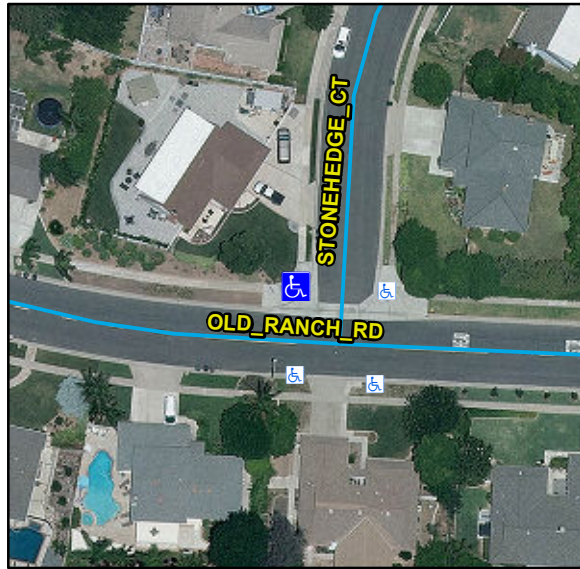
| Compliance | Description | Data | Compliance | Description | Data |
|---|---|---|---|---|---|
| Yes | Ramp Run Slope LT (%) | 3 | No | Ramp Run Slope RT (%) | 10 |
| No | Ramp Cross Slope LT (%) | 2.4 | Yes | Ramp Cross Slope RT (%) | 0.6 |
| No | Ramp Run Slope (%) | 9.2 | N/A | Flare Slope LT (%) | N/A |

Remove & Replace Curb Ramp With Two New Directional Ramps or Equivalent.
