# Access Compliance Report Public Rights-of-Way (Curb Ramps)

| Main Street: KELLOGG_DR | | Cross Street: OLD_RANCH_RD | | Location: | SE |
| ADA ID: RPAT210922095236 | Ramp Type: Type 3 - Combination 1 | Initial Pass/Fail: Fail | Overall Compliance: No | Severity Score: | 19 |

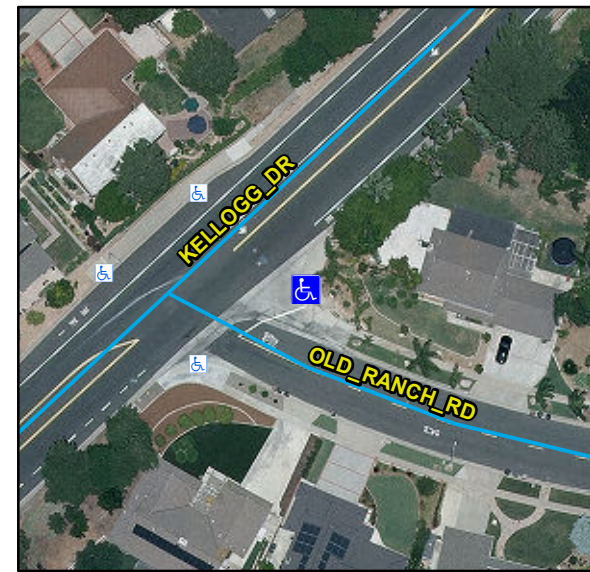
| Compliance | Description | Data | Compliance | Description | Data |
|---|---|---|---|---|---|
| No | Ramp Width LT (in) | 45 | Yes | Ramp Width RT (in) | 50 |
| No | Ramp Run Slope LT (%) | 8.6 | Yes | Ramp Run Slope RT (%) | 2.4 |

**Remove & Replace Curb Ramp With Two New Directional Ramps or Equivalent.**

**R304.2.2, R304.5.1, R304.3.2, STD 1115**
