# Access Compliance Report Public Rights-of-Way (Curb Ramps)

| Main Street: CLUB_VIEW_DR | | Cross Street: KELLOGG_DR | | Location: | NE |
| ADA ID: RPAT210922103231 | Ramp Type: Type 4 - Parallel | Initial Pass/Fail: Pass | Overall Compliance: No | Severity Score: | 5 |

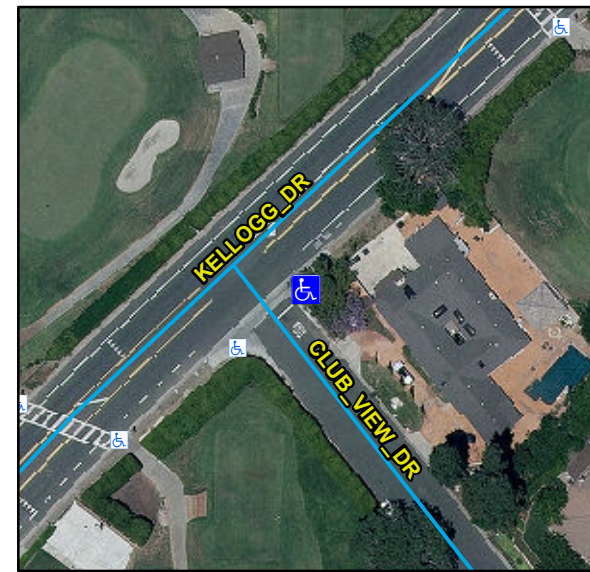
| Compliance | Description | Data | Compliance | Description | Data |
|---|---|---|---|---|---|
| Yes | Gutter Ponding | No | No | Curb Slope | 8.9 |
| No | Gutter Run Slope (%) | 8.1 | | Road Cross Slope (%) | N/A |
| No | Gutter Cross Slope (%) | 2.7 | Yes | Perpendicular Joint Present | Yes |

**Remove & Replace Curb Slope. Remove & Replace Gutter.**

**R304.2.2, R304.5.4, R304.5.3, STD 1115**

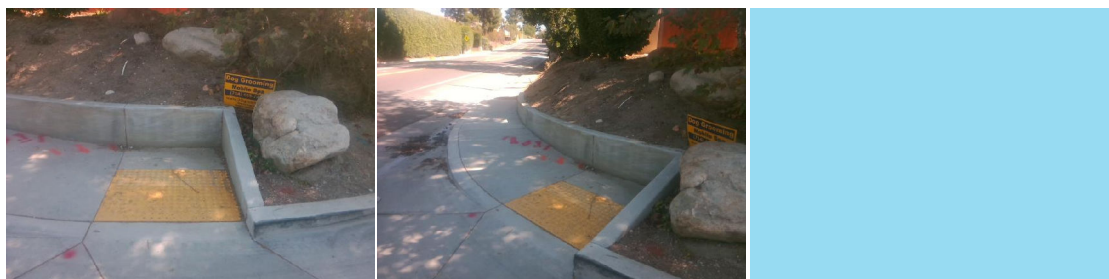
| Compliance | Description | Data | Compliance | Description | Data |
| N/A | Ramp Length LT (in) | 114 | N/A | Ramp Length RT (in) | -9999 |
| Yes | Ramp Width LT (in) | 62 | N/A | Ramp Width RT (in) | -9999 |
| Yes | Ramp Run Slope LT (%) | 5 | N/A | Ramp Run Slope RT (%) | -9999 |
