# Access Compliance Report Public Rights-of-Way (Curb Ramps)

Main Street: CLUB\_VIEW\_DR Cross Street: KELLOGG\_DR Location: SW

ADA ID: RPAT210922104517 Ramp Type: Type 4 - Parallel Initial Pass/Fail: Pass Overall Compliance: No Severity Score: 0

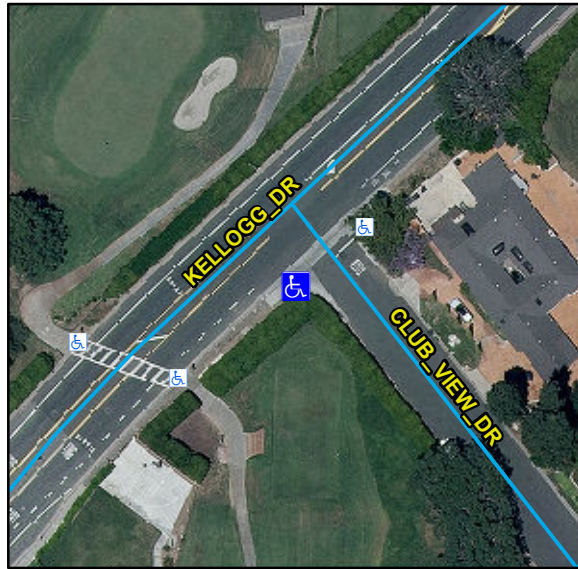
R304.2.2, R304.2.1, R304.2.2-Perp, R304.3.2-Para, STD 1115

| Compliance | Description | Data | Compliance | Description | Data |
|---|---|---|---|---|---|
| No | Landing Run Slope (%) | 2.8 | Yes | DWS Full Width | Yes |
| Yes | Gutter Ponding | No | No | Curb Slope | 55 |

Remove & Replace Entire Ramp.
