# Access Compliance Report Public Rights-of-Way (Curb Ramps)

Main Street: MOUNTAIN\_VIEW\_AVE Cross Street: KELLOGG\_DR Location: SE

ADA ID: RPAT210922121813 Ramp Type: Type 1 - Perpendicular Diagonal Initial Pass/Fail: Pass Overall Compliance: No Severity Score: 10

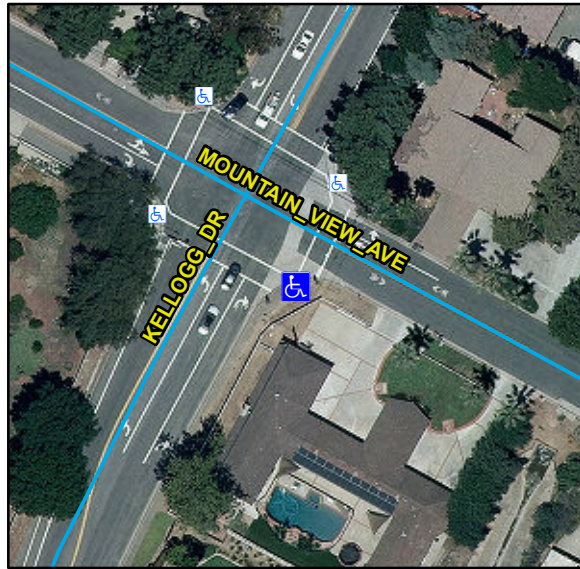
| Compliance | Description | Data | Compliance | Description | Data |
|---|---|---|---|---|---|
| No | Landing Run Slope (%) | 4.8 | N/A | Flare Traversable RT | No |
| No | Landing Cross Slope (%) | 7.4 | Yes | DWS Provided | Yes |
| No | Gutter Run Slope (%) | 6.3 | | Road Cross Slope (%) | 2.1 |
| No | Gutter Cross Slope (%) | 3.6 | | | |

Remove & Replace Landing. Remove & Replace Gutter.
