# Access Compliance Report Public Rights-of-Way (Curb Ramps)

Main Street: KELLOGG\_DR Cross Street: MOUNTAIN\_VIEW\_AVE Location: SW

ADA ID: RPAT210922125709 Ramp Type: Type 1 - Perpendicular Diagonal Initial Pass/Fail: Pass Overall Compliance: No Severity Score: 2

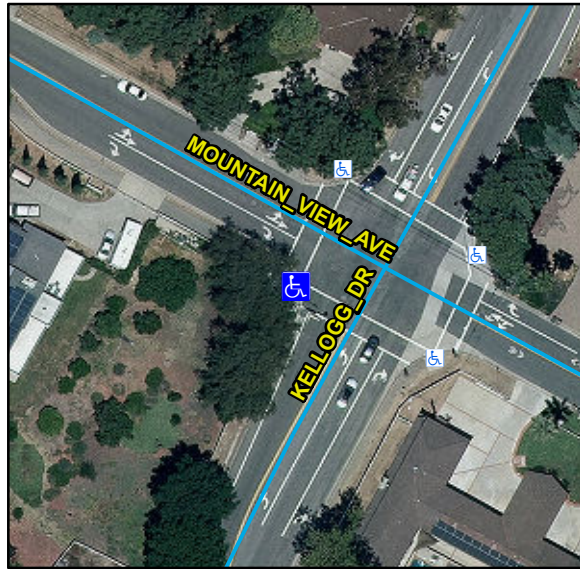
| Compliance | Description | Data | Compliance | Description | Data |
|---|---|---|---|---|---|
| No | Ramp Cross Slope (%) | 4.3 | N/A | Flare Traversable LT | No |
| No | Landing Cross Slope (%) | 4.7 | Yes | DWS Provided | Yes |
| No | Gutter Cross Slope (%) | 8.5 | | | |

Remove & Replace Curb Ramp With Two New Directional Ramps or Equivalent. Remove & Replace Gutter.

R304.2.2, R304.5.3, STD 1115
