# Access Compliance Report Public Rights-of-Way (Curb Ramps)

Main Street: KELLOGG\_DR Cross Street: SHADOW\_HILL\_DR Location: SW

ADA ID: RPAT210922132010 Ramp Type: Type 1 - Perpendicular Diagonal Initial Pass/Fail: Fail Overall Compliance: No Severity Score: 30

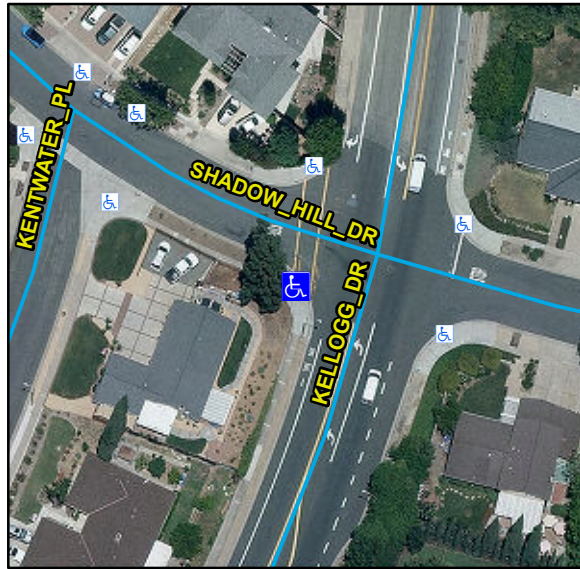
| Compliance | Description | Data | Compliance | Description | Data |
|---|---|---|---|---|---|
| No | Ramp Cross Slope (%) | 12.2 | N/A | Flare Traversable LT | N/A |

Remove & Replace Curb Ramp With Two New Directional Ramps or Equivalent.
