# Access Compliance Report Public Rights-of-Way (Curb Ramps)

Main Street: SHADOW\_HILL\_DR Cross Street: KELLOGG\_DR Location: SE

ADA ID: RPAT210922132733 Ramp Type: Type 1 - Perpendicular Diagonal Initial Pass/Fail: Fail Overall Compliance: No Severity Score: 30

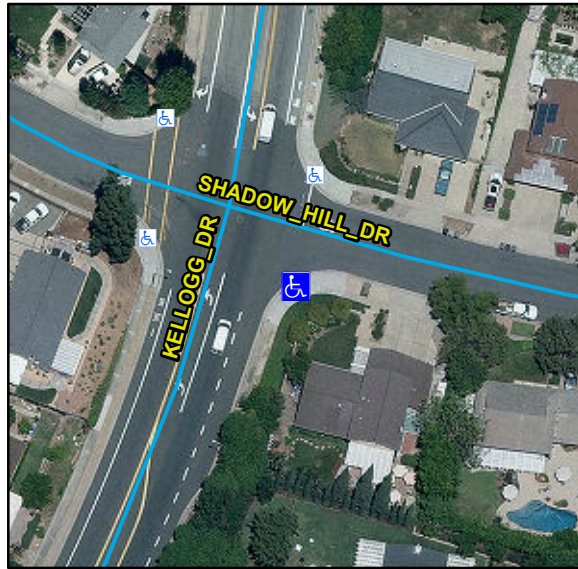
| Compliance | Description | Data | Compliance | Description | Data |
|---|---|---|---|---|---|
| No | Ramp Run Slope (%) | 9.3 | N/A | Flare Slope LT (%) | N/A |
| No | Ramp Cross Slope (%) | 5.1 | N/A | Flare Traversable LT | N/A |

Remove & Replace Curb Ramp With Two New Directional Ramps or Equivalent.

R304.2.2, R304.5.3, STD 1115
