# Access Compliance Report Public Rights-of-Way (Curb Ramps)

Main Street: KELLOGG\_DR Cross Street: SHADOW\_HILL\_DR Location: NE

ADA ID: RPAT210922133222 Ramp Type: Type 1 - Perpendicular Diagonal Initial Pass/Fail: Fail Overall Compliance: No Severity Score: 15

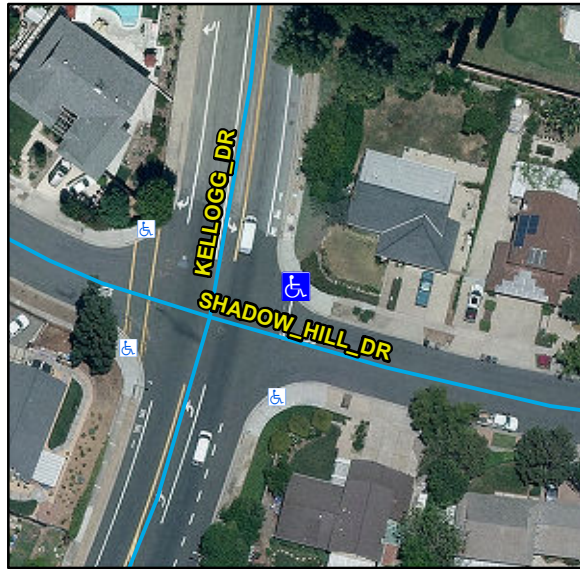
| Compliance | Description | Data | Compliance | Description | Data |
|---|---|---|---|---|---|
| No | Ramp Cross Slope (%) | 6.2 | N/A | Flare Traversable LT | N/A |
| N/A | Gutter Ponding | N/A | No | Curb Slope | 8.9 |

Remove & Replace Curb Ramp With Two New Directional Ramps or Equivalent.

R304.2.2, R304.5.3, STD 1115
