# Access Compliance Report Public Rights-of-Way (Curb Ramps)

Main Street: SHADOW\_HILL\_DR Cross Street: KELLOGG\_DR Location: NW

ADA ID: RPAT210922133553 Ramp Type: Type 1 - Perpendicular Diagonal Initial Pass/Fail: Pass Overall Compliance: No Severity Score: 46

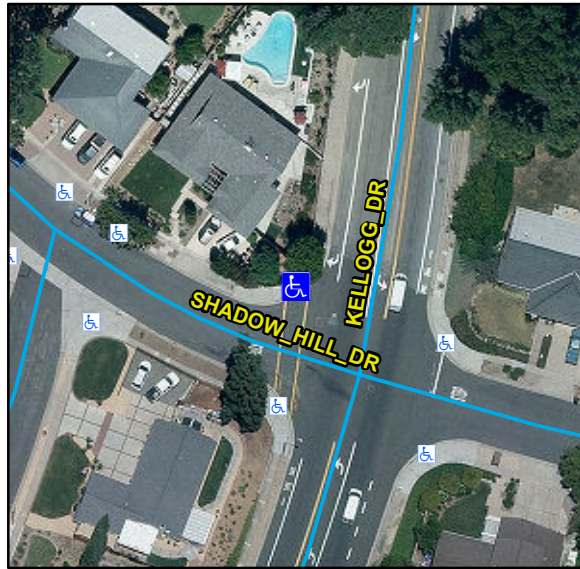
| Compliance | Description | Data | Compliance | Description | Data |
|---|---|---|---|---|---|
| No | Ramp Cross Slope (%) | 10.8 | N/A | Flare Traversable LT | Yes |
| Yes | Landing Width (in) | 48 | No | Flare Slope RT (%) | 11.6 |
| No | Landing Cross Slope (%) | 10.2 | Yes | DWS Provided | Yes |
| No | Gutter Run Slope (%) | 5.6 | | Road Cross Slope (%) | 5.8 |
| No | Gutter Cross Slope (%) | 8.4 | | | |

Remove & Replace Curb Ramp With Two New Directional Ramps or Equivalent. Remove & Replace Gutter.
