# Access Compliance Report Public Rights-of-Way (Curb Ramps)

Main Street: SHADOW\_HILL\_DR Cross Street: KENTWATER\_PL Location: SE

ADA ID: RPAT210922134211 Ramp Type: Type 1 - Perpendicular Diagonal Initial Pass/Fail: Pass Overall Compliance: No Severity Score: 6

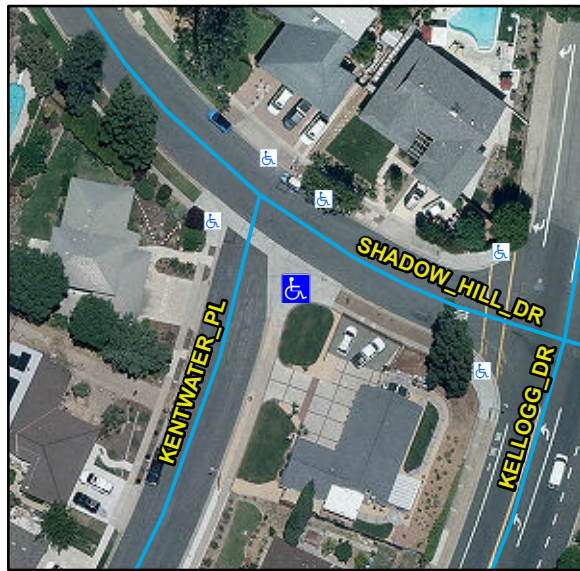
| Compliance | Description | Data | Compliance | Description | Data |
|---|---|---|---|---|---|
| No | Ramp Cross Slope (%) | 3.4 | N/A | Flare Traversable LT | Yes |
| No | Landing Cross Slope (%) | 3.2 | Yes | DWS Provided | Yes |
| Yes | Gutter Ponding | No | No | Curb Slope | 8.2 |

Remove & Replace Curb Ramp With Two New Directional Ramps or Equivalent.

R304.2.2, R304.5.3, R304.2.1, STD 1115

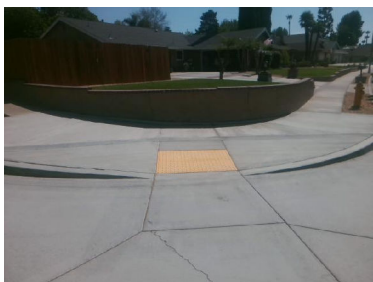
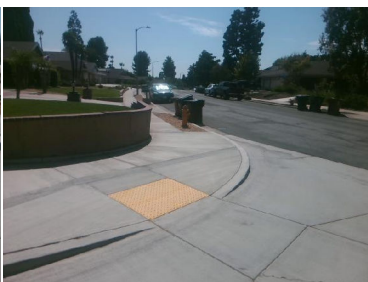
| Compliance | Description | Data | Compliance | Description | Data |
|---|---|---|---|---|---|
| Yes | Overall Surface Condition: Acceptable | | Yes | Perp Joint Present | Yes |
