# Access Compliance Report Public Rights-of-Way (Curb Ramps)

Main Street: KENTWATER\_PL Cross Street: SHADOW\_HILL\_DR Location: SW

ADA ID: RPAT210922134725 Ramp Type: Type 1 - Perpendicular Diagonal Initial Pass/Fail: Pass Overall Compliance: No Severity Score: 4

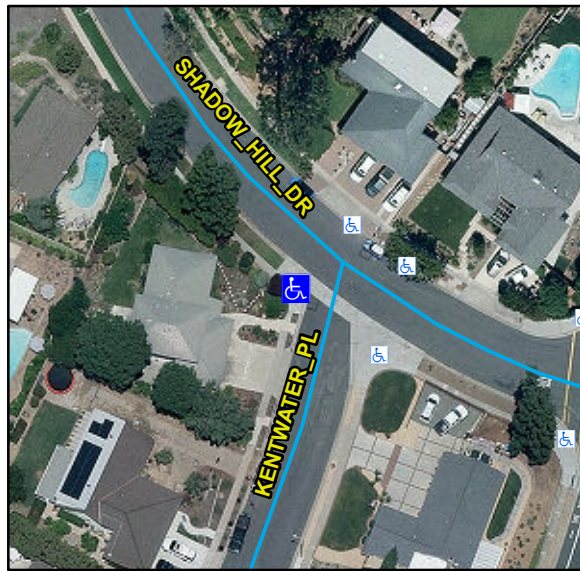
| Compliance | Description | Data | Compliance | Description | Data |
|---|---|---|---|---|---|
| No | Landing Run Slope (%) | 2.6 | N/A | Flare Traversable RT | No |
| Yes | Gutter Ponding | No | No | Curb Slope | 8.6 |

Remove & Replace Curb Ramp With Two New Directional Ramps or Equivalent.
