# Access Compliance Report Public Rights-of-Way (Curb Ramps)

Main Street: SHADOW\_HILL\_DR Cross Street: WENDOVER\_RD Location: SW

ADA ID: RPAT210922141512 Ramp Type: Type 1 - Perpendicular Diagonal Initial Pass/Fail: Fail Overall Compliance: No Severity Score: 15

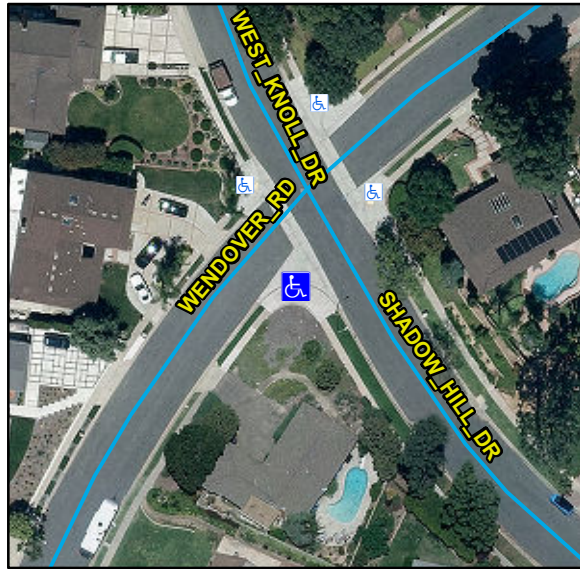
| Compliance | Description | Data | Compliance | Description | Data |
|---|---|---|---|---|---|
| No | Ramp Cross Slope (%) | 6.7 | N/A | Flare Traversable LT | N/A |

Remove & Replace Curb Ramp With Two New Directional Ramps or Equivalent.

R304.2.2, R304.5.3, STD 1115
