# Access Compliance Report Public Rights-of-Way (Curb Ramps)

Main Street: WENDOVER\_RD Cross Street: SHADOW\_HILL\_DR Location: SE

ADA ID: RPAT210922141732 Ramp Type: Type 1 - Perpendicular Diagonal Initial Pass/Fail: Pass Overall Compliance: No Severity Score: 19

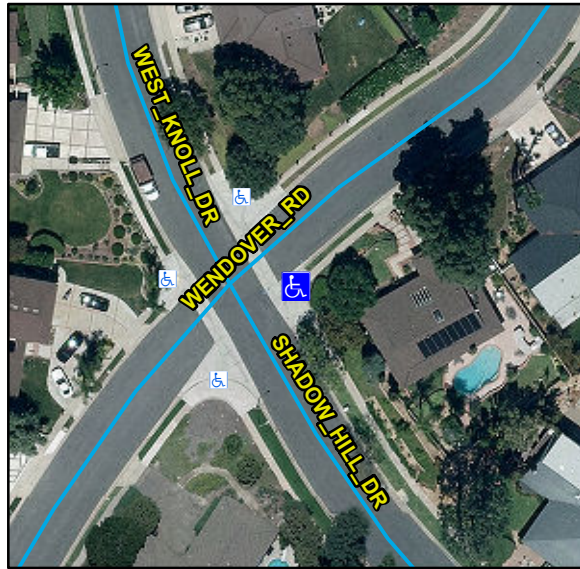
| Compliance | Description | Data | Compliance | Description | Data |
|---|---|---|---|---|---|
| No | Ramp Cross Slope (%) | 5.3 | N/A | Flare Traversable LT | No |
| No | Gutter Cross Slope (%) | 6 | | | |

Remove & Replace Curb Ramp With Two New Directional Ramps or Equivalent. Remove & Replace Gutter.
