# Access Compliance Report Public Rights-of-Way (Curb Ramps)

Main Street: KELLOGG\_DR Cross Street: YORBA\_LINDA\_BLVD Location: SW

ADA ID: RPAT210922145452 Ramp Type: Type 3 - Combination 1 Initial Pass/Fail: Pass Overall Compliance: Yes Severity Score: 0

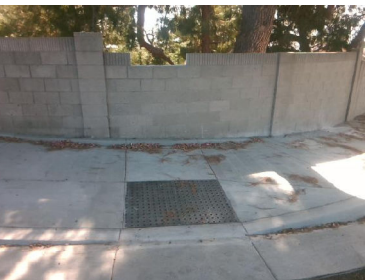
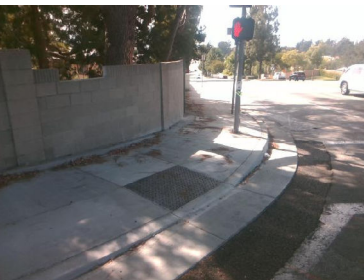
| Compliance | Description | Data | Compliance | Description | Data |
|---|---|---|---|---|---|
| Yes | Overall Surface Condition: Acceptable | | | | |
