# Access Compliance Report Public Rights-of-Way (Curb Ramps)

Main Street: **KELLOGG\_DR** Cross Street: **PARK\_RIDGE\_AVE** Location: **NE**

ADA ID: **RPAT210922151918** Ramp Type: **Type 3 - Combination 1** Initial Pass/Fail: **Fail** Overall Compliance: **No** Severity Score: **16**

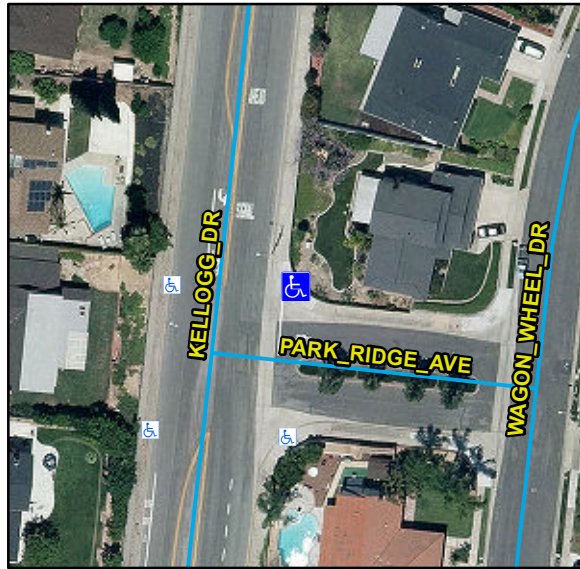
| Compliance | Description | Data | Compliance | Description | Data |
|---|---|---|---|---|---|
| <b>No</b> | Ramp Run Slope LT (%) | <b>10.4</b> | <b>Yes</b> | Ramp Run Slope RT (%) | <b>0.9</b> |
| <b>Yes</b> | Ramp Cross Slope LT (%) | <b>1.1</b> | <b>No</b> | Ramp Cross Slope RT (%) | <b>2.4</b> |
| <b>No</b> | Ramp Cross Slope (%) | <b>3.2</b> | <b>N/A</b> | Flare Traversable LT | <b>N/A</b> |

**Remove & Replace Curb Ramp With Two New Directional Ramps or Equivalent.**

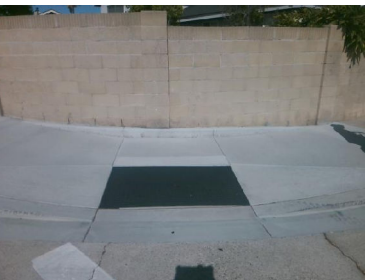
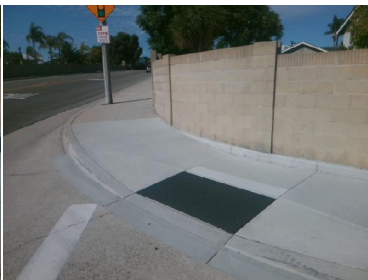
| Compliance | Description | Data | Compliance | Description | Data |
|---|---|---|---|---|---|
| <b>Yes</b> | Overall Surface Condition: <b>Acceptable</b> | | | | |
