# Access Compliance Report Public Rights-of-Way (Curb Ramps)

Main Street: PARK RIDGE\_AVE Cross Street: KELLOGG\_DR Location: SE

ADA ID: RPAT210922152326 Ramp Type: Type 3 - Combination 1 Initial Pass/Fail: Fail Overall Compliance: No Severity Score: 30

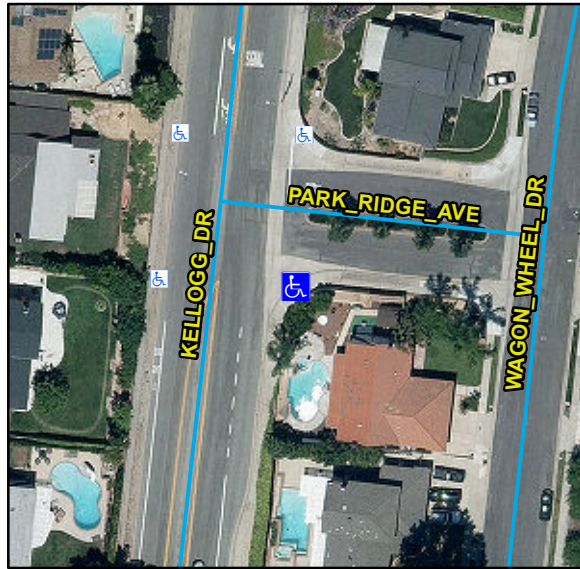
| Compliance | Description | Data | Compliance | Description | Data |
|---|---|---|---|---|---|
| No | Ramp Run Slope LT (%) | 9.6 | Yes | Ramp Run Slope RT (%) | 3 |
| Yes | Ramp Cross Slope LT (%) | 1.7 | No | Ramp Cross Slope RT (%) | 2.3 |
| No | Ramp Cross Slope (%) | 6.5 | N/A | Flare Traversable LT | N/A |

Remove & Replace Curb Ramp With Two New Directional Ramps or Equivalent.

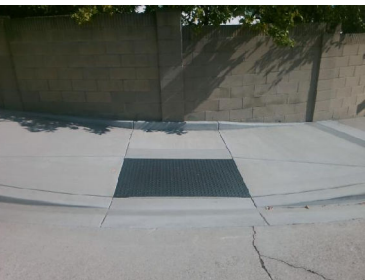
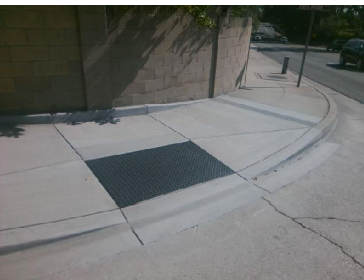
| Compliance | Description | Data | Compliance | Description | Data |
|---|---|---|---|---|---|
| Yes | Overall Surface Condition: Acceptable | | | | |
