# Access Compliance Report Public Rights-of-Way (Curb Ramps)

Main Street: CLUB\_TERRACE\_DR Cross Street: YORBA\_LINDA\_BLVD Location: SE

ADA ID: RPAT210923081515 Ramp Type: Type 4 - Parallel Initial Pass/Fail: Pass Overall Compliance: No Severity Score: 0

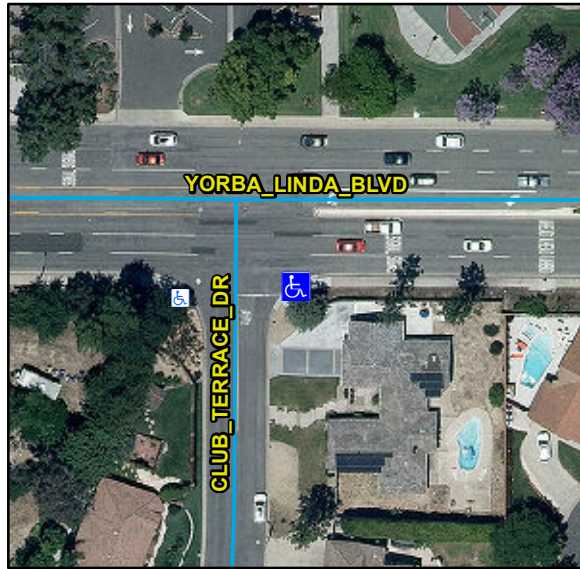
| Compliance | Description | Data | Compliance | Description | Data |
|---|---|---|---|---|---|
| N/A | Landing Present | Yes | Yes | DWS Provided | Yes |
| N/A | Landing Length (in) | 53 | Yes | DWS Contrast | Yes |
| No | Landing Run Slope (%) | 2.2 | Yes | DWS Full Width | Yes |

Possible Solutions:

Remove & Replace Landing.

R304.2.2-Perp, R304.3.2-Para, STD 1115
