# Access Compliance Report Public Rights-of-Way (Curb Ramps)

Main Street: CRESTKNOLL\_DR Cross Street: GLENKNOLL\_DR Location: SE

ADA ID: RPAT210923085926 Ramp Type: Type 3 - Combination 1 Initial Pass/Fail: Fail Overall Compliance: No Severity Score: 4

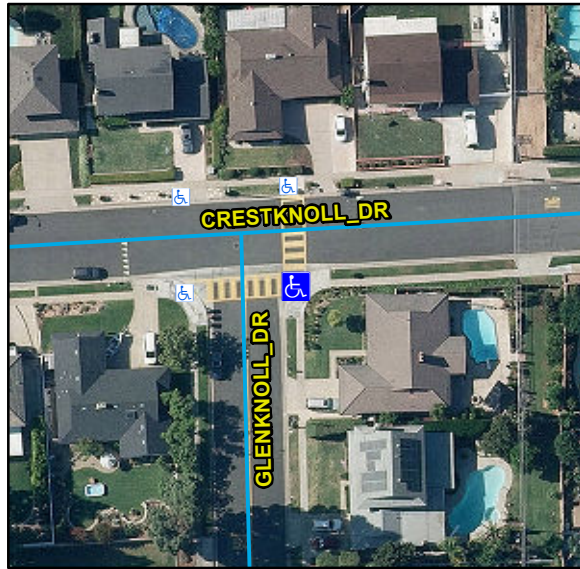
| Compliance | Description | Data | Compliance | Description | Data |
|---|---|---|---|---|---|
| No | Ramp Width LT (in) | 44 | No | Ramp Width RT (in) | 43 |

Remove & Replace Curb Ramp With Two New Directional Ramps or Equivalent. Remove & Replace Sidewalk.

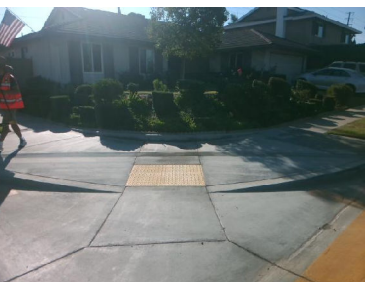
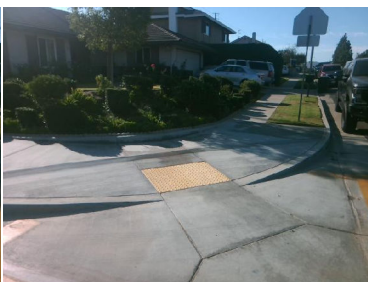
| Compliance | Description | Data | Compliance | Description | Data |
|---|---|---|---|---|---|
| N/A | Ramp Length LT (in) | 64 | N/A | Ramp Length RT (in) | 77 |
| Yes | Ramp Run Slope LT (%) | 6.7 | Yes | Ramp Run Slope RT (%) | 3.1 |
| Yes | Ramp Cross Slope LT (%) | 1.6 | Yes | Ramp Cross Slope RT (%) | 1.1 |
| N/A | Gutter Ponding | N/A | No | Curb Slope | 9.6 |
