# Access Compliance Report Public Rights-of-Way (Curb Ramps)

Main Street: CRESTKNOLL\_DR Cross Street: GLENKNOLL\_DR Location: NE

ADA ID: RPAT210923090310 Ramp Type: Type 3 - Combination 1 Initial Pass/Fail: Fail Overall Compliance: No Severity Score: 35

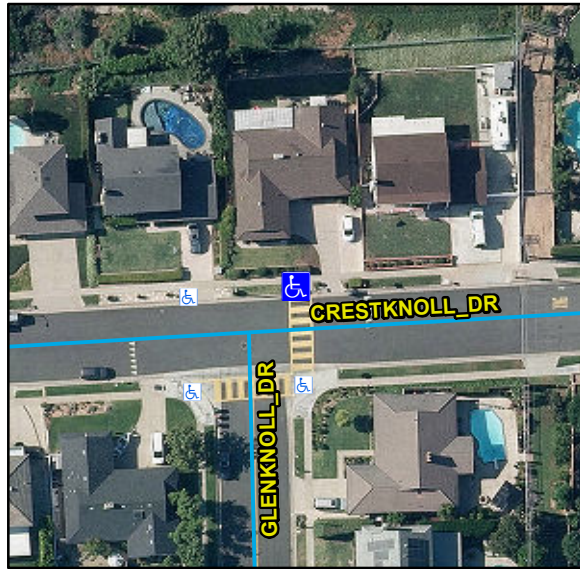
| Compliance | Description | Data | Compliance | Description | Data |
|---|---|---|---|---|---|
| No | Ramp Width LT (in) | 47 | No | Ramp Width RT (in) | 47 |
| Yes | Ramp Run Slope LT (%) | 3.6 | No | Ramp Run Slope RT (%) | 13.3 |
| Yes | Ramp Cross Slope LT (%) | 1.7 | No | Ramp Cross Slope RT (%) | 3 |
| No | Ramp Width (in) | 42 | | | N/A |
| No | Ramp Run Slope (%) | 8.8 | N/A | Flare Slope LT (%) | N/A |
| No | Ramp Cross Slope (%) | 2.4 | N/A | Flare Traversable LT | N/A |

Possible Solutions:

Remove & Replace Entire Ramp.

R304.2.2, R304.5.1, R304.5.3, R304.3.2, STD 1115
