# Access Compliance Report Public Rights-of-Way (Curb Ramps)

| Main Street: CRESTKNOLL_DR | | Cross Street: GLENDALE_DR | | Location: | NW |
| ADA ID: RPAT210923090808 | Ramp Type: Type 4 - Parallel | Initial Pass/Fail: Fail | Overall Compliance: No | Severity Score: | 15 |

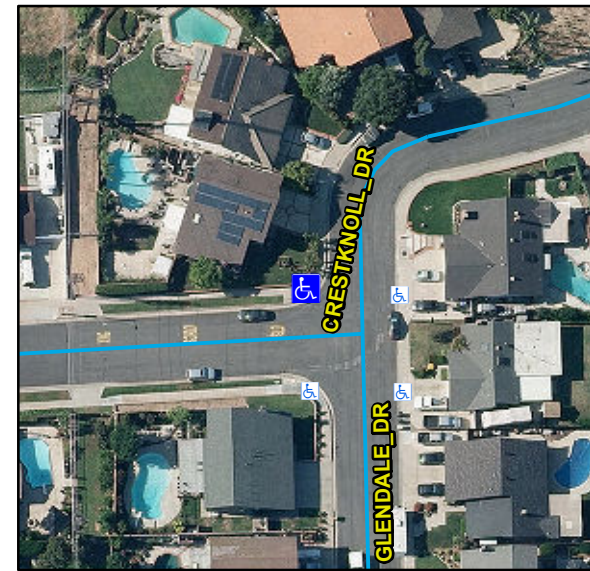
| Compliance | Description | Data | Compliance | Description | Data |
|---|---|---|---|---|---|
| No | Ramp Run Slope LT (%) | 8.4 | No | Ramp Run Slope RT (%) | 10.5 |

**Remove & Replace Curb Ramp With Two New Directional Ramps or Equivalent.**

**R304.3.2, STD 1115**
