# Access Compliance Report Public Rights-of-Way (Curb Ramps)

Main Street: GLENDALE\_DR Cross Street: CRESTKNOLL\_DR Location: SW

ADA ID: RPAT210923091230 Ramp Type: Type 4 - Parallel Initial Pass/Fail: Fail Overall Compliance: No Severity Score: 15

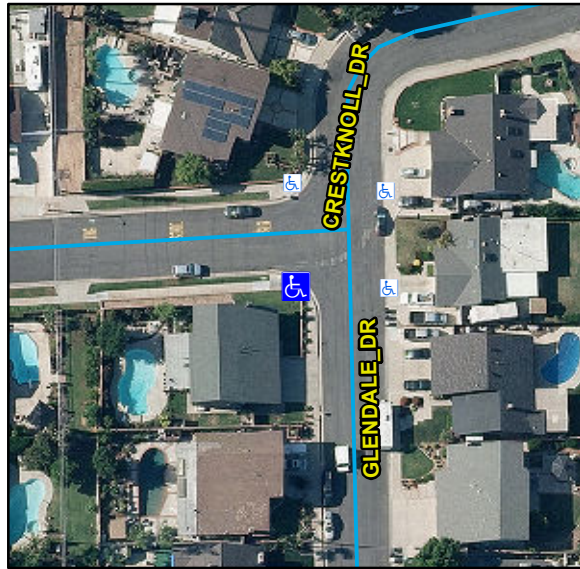
| Compliance | Description | Data | Compliance | Description | Data |
|---|---|---|---|---|---|
| No | Ramp Run Slope LT (%) | 11.1 | Yes | Ramp Run Slope RT (%) | 6.5 |

**Remove & Replace Curb Ramp With Two New Directional Ramps or Equivalent.**

**R304.3.2, STD 1115**
