# Access Compliance Report Public Rights-of-Way (Curb Ramps)

Main Street: LARKRIDGE\_DR Cross Street: GLENKNOLL\_DR Location: NW

ADA ID: RPAT210923092400 Ramp Type: Type 1 - Perpendicular Diagonal Initial Pass/Fail: Fail Overall Compliance: No Severity Score: 2

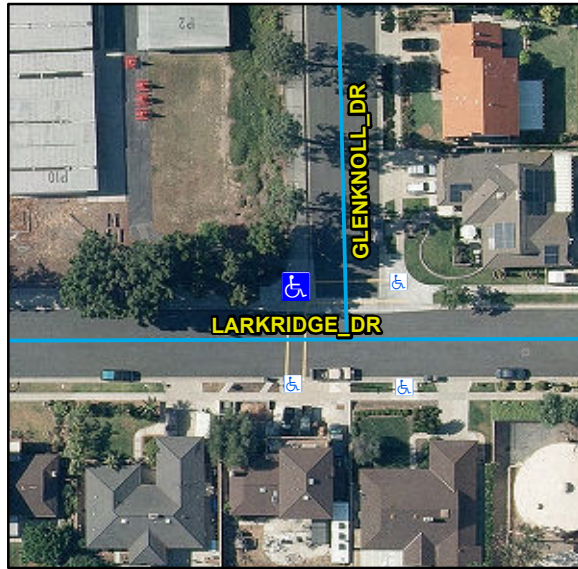
| Compliance | Description | Data | Compliance | Description | Data |
|---|---|---|---|---|---|
| No | Ramp Cross Slope (%) | 2.7 | N/A | Flare Traversable LT | N/A |

Remove & Replace Curb Ramp With Two New Directional Ramps or Equivalent.

R304.2.2, R304.5.3, STD 1115
