Access Compliance Report Public Rights-of-Way (Curb Ramps)

Main Street: CRESTKNOLL_DR **Cross Street:** LARKRIDGE_DR **Location:** SE

ADA ID: RPAT210923094114 **Ramp Type:** Type 3 - Combination 1 **Initial Pass/Fail:** Fail **Overall Compliance:** No **Severity Score:** 16

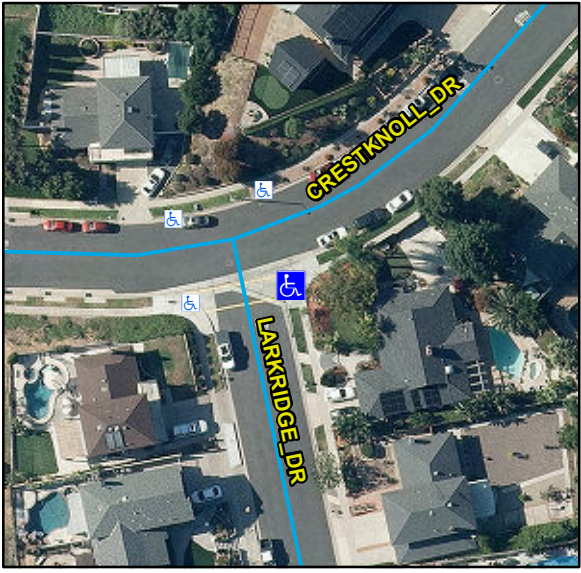
Compliance	Description	Data	Compliance	Description	Data
N/A	Ramp Length LT (in)	88	N/A	Ramp Length RT (in)	75
Yes	Ramp Width LT (in)	48	Yes	Ramp Width RT (in)	50
No	Ramp Run Slope LT (%)	11.9	No	Ramp Run Slope RT (%)	8.7
No	Ramp Cross Slope LT (%)	3.3	Yes	Ramp Cross Slope RT (%)	0.9
N/A	Ramp Length (in)	46	N/A	Flare Type LT	
Yes	Ramp Width (in)	48			N/A
No	Ramp Run Slope (%)	8.6	N/A	Flare Slope LT (%)	N/A
No	Ramp Cross Slope (%)	2.4	N/A	Flare Traversable LT	N/A
N/A	Landing Present	N/A	N/A	Flare Type RT	
N/A	Landing Length (in)	N/A			N/A
N/A	Landing Width (in)	N/A	N/A	Flare Slope RT (%)	N/A
N/A	Landing Run Slope (%)	N/A	N/A	Flare Traversable RT	N/A
N/A	Landing Cross Slope (%)	N/A	N/A	DWS Provided	N/A
N/A	Landing Movement Obstructed?	N/A	N/A	DWS Contrast	N/A
	Landing Movement Type	N/A	N/A	DWS Length (in)	N/A
N/A	Landing Shared	N/A	N/A	DWS Full Width	N/A
N/A	Clear Space	Yes		DWS Offset Type	N/A
N/A	Clear Space To Crosswalk (in)	N/A	N/A	DWS Offset Left (in)	N/A

N/A	DWS Offset Right (in)	N/A
Yes	Perp Joint Present	Yes			
	Parallel Ramp Side	N/A			
N/A	Marked Crosswalk 1	No	N/A	Marked Crosswalk 2	Yes
	Crossing 1 Direction	N		Crossing 2 Direction	W
	Marked Crosswalk 1 Width (in)	N/A		Marked Crosswalk 2 Width (in)	120
N/A	Ramp Inside Crosswalk 1	N/A	Yes	Ramp Inside Crosswalk 2	Yes
	Crossing 1 Slope (%)	6.9		Crossing 2 Slope (%)	7.3
	Crossing 1 Cross Slope (%)	7.9		Crossing 2 Cross Slope (%)	0.8
N/A	Gutter Ponding	N/A	No	Curb Slope	17.6
Yes	Gutter Lip Height (in)	0		Road Run Slope (%)	2.3
N/A	Gutter Run Slope (%)	N/A		Road Cross Slope (%)	3
N/A	Gutter Cross Slope (%)	N/A			
Yes	Overall Surface Condition:	Acceptable			
	Cross Gutter Present?	Yes		Spandrel Present?	Yes
	Replace Cross Gutter?	No		Replace Spandrel?	No

Possible Solutions:
Remove & Replace Curb Ramp With Two New Directional Ramps or Equivalent.

OC Std/PROW:
 R304.2.2, R304.5.3, R304.3.2, STD 1115
