# Access Compliance Report Public Rights-of-Way (Curb Ramps)

| Main Street: FAIRLYNN_BLV | | Cross Street: CRESTKNOLL_DR | | Location: | NE |
| ADA ID: RPAT210923094629 | Ramp Type: Type 4 - Parallel | Initial Pass/Fail: Fail | Overall Compliance: No | Severity Score: | 32 |

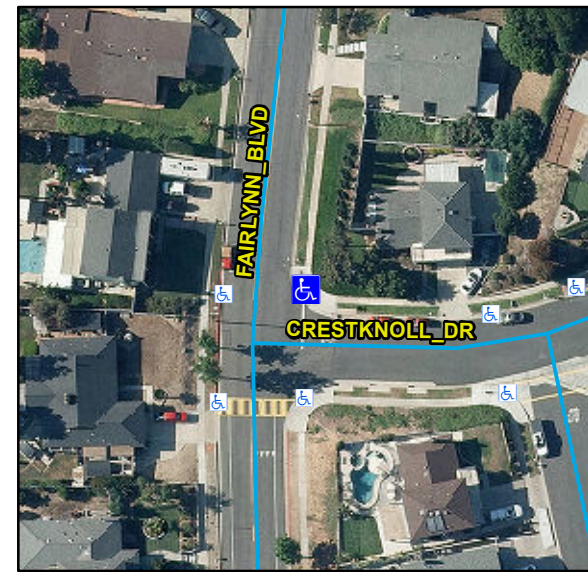
| Compliance | Description | Data | Compliance | Description | Data |
|---|---|---|---|---|---|
| Yes | Ramp Run Slope LT (%) | 6.9 | No | Ramp Run Slope RT (%) | 15.4 |
| Yes | Ramp Cross Slope LT (%) | 0.3 | No | Ramp Cross Slope RT (%) | 3.3 |

Possible Solutions:

**Remove & Replace Curb Ramp With Two New Directional Ramps or Equivalent.**

**R304.3.2, R304.5.3, STD 1115**

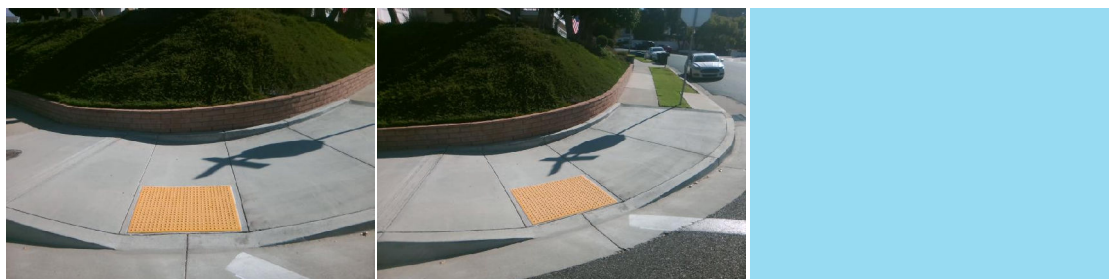
| Compliance | Description | Data | Compliance | Description | Data |
|---|---|---|---|---|---|
| N/A | Ramp Length LT (in) | 36 | N/A | Ramp Length RT (in) | 57 |
| Yes | Ramp Width LT (in) | 109 | Yes | Ramp Width RT (in) | 104 |
