# Access Compliance Report Public Rights-of-Way (Curb Ramps)

| Main Street: CRESTKNOLL_DR | Cross Street: FAIRLYNN_BLVD | Location: | SE |

| ADA ID: RPAT210923094940 | Ramp Type: Type 4 - Parallel | Initial Pass/Fail: Fail | Overall Compliance: No | Severity Score: | 16 |

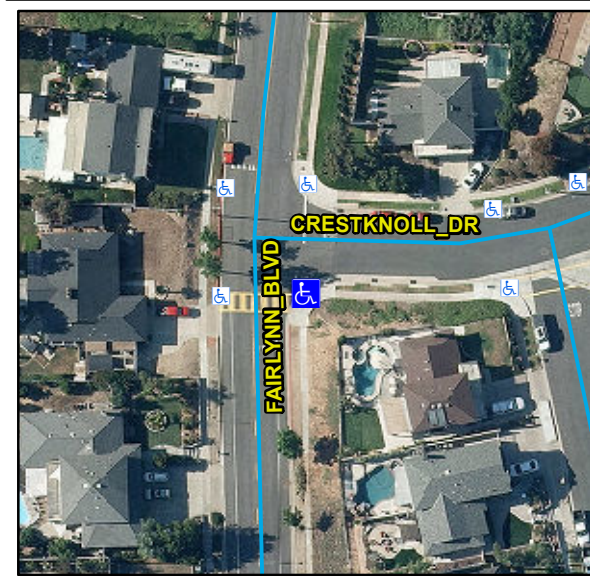
| Compliance | Description | Data | Compliance | Description | Data |
|---|---|---|---|---|---|
| Yes | Ramp Run Slope LT (%) | 8.1 | No | Ramp Run Slope RT (%) | 9.9 |
| No | Ramp Cross Slope LT (%) | 3.3 | Yes | Ramp Cross Slope RT (%) | 0.2 |

Possible Solutions:

**Remove & Replace Curb Ramp With Two New Directional Ramps or Equivalent.**

**R304.5.3, R304.3.2, STD 1115**

Total Cost: \$ 4000

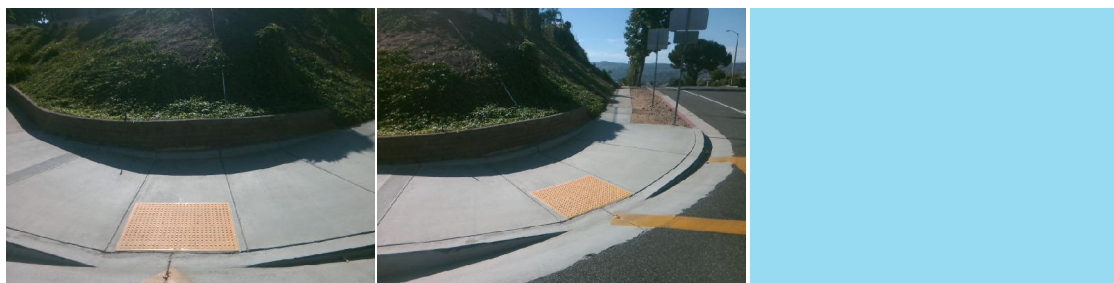
| Compliance | Description | Data | Compliance | Description | Data |
|---|---|---|---|---|---|
| N/A | Ramp Length LT (in) | 56 | N/A | Ramp Length RT (in) | 55 |
| Yes | Ramp Width LT (in) | 98 | Yes | Ramp Width RT (in) | 104 |
