# Access Compliance Report Public Rights-of-Way (Curb Ramps)

Main Street: FAIRLYNN\_BLV D Cross Street: OAKVALE\_DR Location: NE

ADA ID: RPAT210923101938 Ramp Type: Type 4 - Parallel Initial Pass/Fail: Fail Overall Compliance: No Severity Score: 15

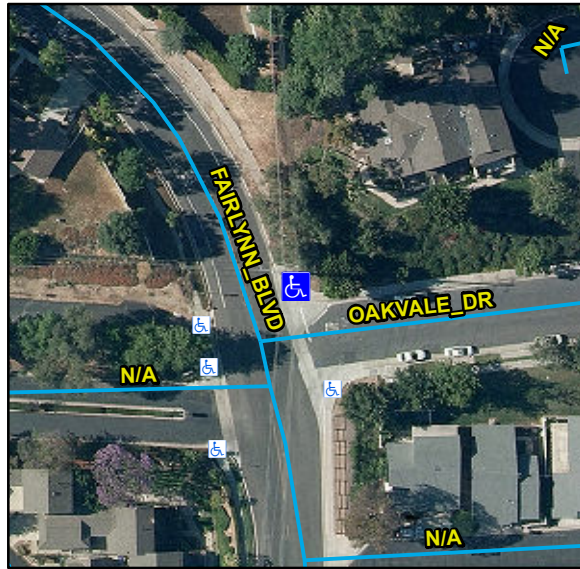
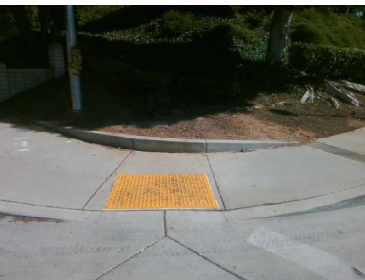
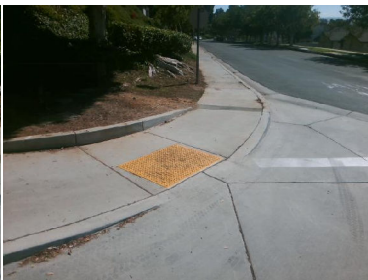
| Compliance | Description | Data | Compliance | Description | Data |
|---|---|---|---|---|---|
| No | Ramp Run Slope LT (%) | 8.7 | Yes | Ramp Run Slope RT (%) | 6.6 |

Remove & Replace Curb Ramp With Two New Directional Ramps or Equivalent.
