# Access Compliance Report Public Rights-of-Way (Curb Ramps)

Main Street: OAKVALE\_DR Cross Street: FAIRLYNN\_BLVD Location: SE

ADA ID: RPAT210923102713 Ramp Type: Type 4 - Parallel Initial Pass/Fail: Fail Overall Compliance: No Severity Score: 15

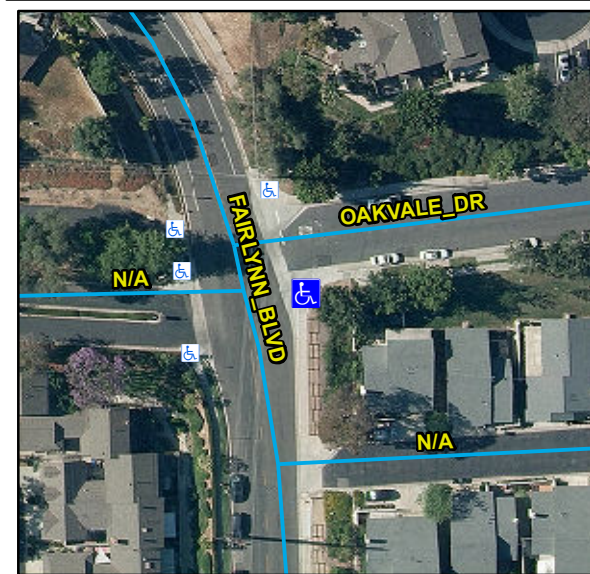
| Compliance | Description | Data | Compliance | Description | Data |
|---|---|---|---|---|---|
| No | Ramp Run Slope LT (%) | 10.9 | Yes | Ramp Run Slope RT (%) | 2.2 |

Possible Solutions:  
**Remove & Replace Curb Ramp With Two New Directional Ramps or Equivalent.**

OC Std/PROW:  
**R304.3.2, STD 1115**
