# Access Compliance Report Public Rights-of-Way (Curb Ramps)

Main Street: N/A Cross Street: FAIRLYNN BLVD Location: NW

ADA ID: RPAT210923103327 Ramp Type: Type 6 - Directional 1 Initial Pass/Fail: Fail Overall Compliance: No Severity Score: 4

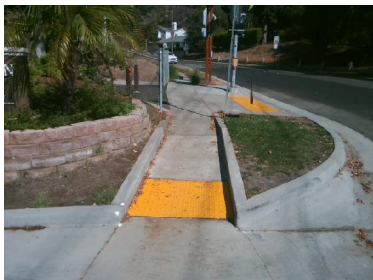
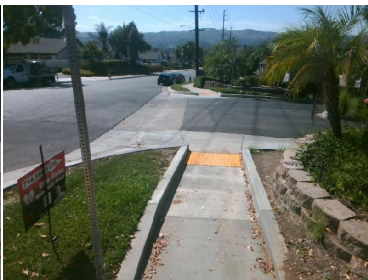
| Compliance | Description | Data | Compliance | Description | Data |
|---|---|---|---|---|---|
| No | Ramp Width (in) | 47 | | | N/A |

Remove & Replace Entire Ramp.
