# Access Compliance Report Public Rights-of-Way (Curb Ramps)

Main Street: N/A Cross Street: FAIRLYNN BLVD Location: SW

ADA ID: RPAT210923103650 Ramp Type: Type 6 - Directional 1 Initial Pass/Fail: Pass Overall Compliance: No Severity Score: 10

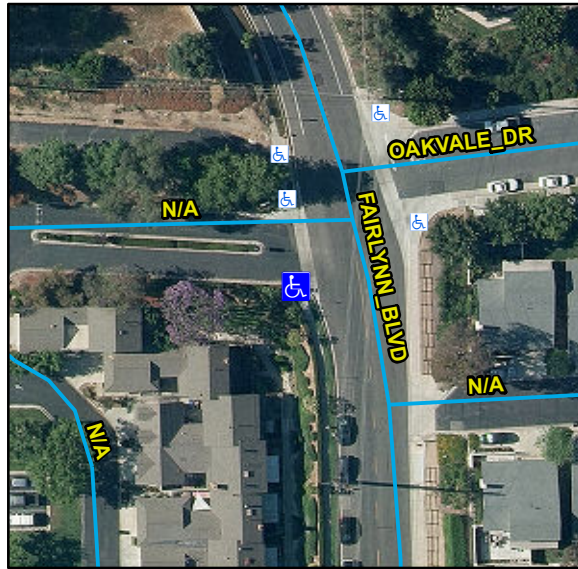
| Compliance | Description | Data | Compliance | Description | Data |
|---|---|---|---|---|---|
| No | Grade Break | No | Yes | Flare Type RT | |
| No | Landing Run Slope (%) | 8.7 | | DWS Offset Type | Multiple |
| No | Gutter Run Slope (%) | 7.5 | | Road Cross Slope (%) | N/A |
| No | Gutter Cross Slope (%) | 2.3 | | Parallel Ramp Side | N/A |

Remove & Replace Entire Ramp. Remove & Replace Gutter.
