# Access Compliance Report Public Rights-of-Way (Curb Ramps)

Main Street: N/A Cross Street: OAKVALE\_DR Location: NE

ADA ID: RPAT210923121352 Ramp Type: Type 1 - Perpendicular Diagonal Initial Pass/Fail: Fail Overall Compliance: No Severity Score: 30

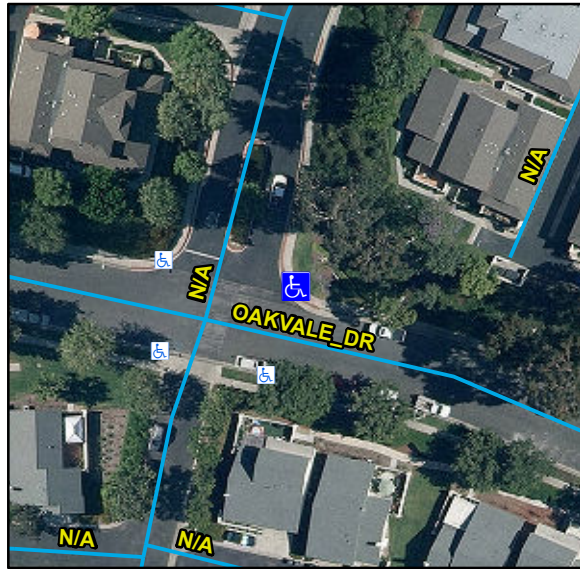
| Compliance | Description | Data | Compliance | Description | Data |
|---|---|---|---|---|---|
| No | Ramp Run Slope (%) | 14.6 | N/A | Flare Slope LT (%) | N/A |

Remove & Replace Curb Ramp With Two New Directional Ramps or Equivalent.

R204.3, R304.2.2, STD 1115
