# Access Compliance Report Public Rights-of-Way (Curb Ramps)

Main Street: OAKVALE\_DR Cross Street: N/A Location: NW

ADA ID: RPAT210923121737 Ramp Type: Type 1 - Perpendicular Diagonal Initial Pass/Fail: Fail Overall Compliance: No Severity Score: 32

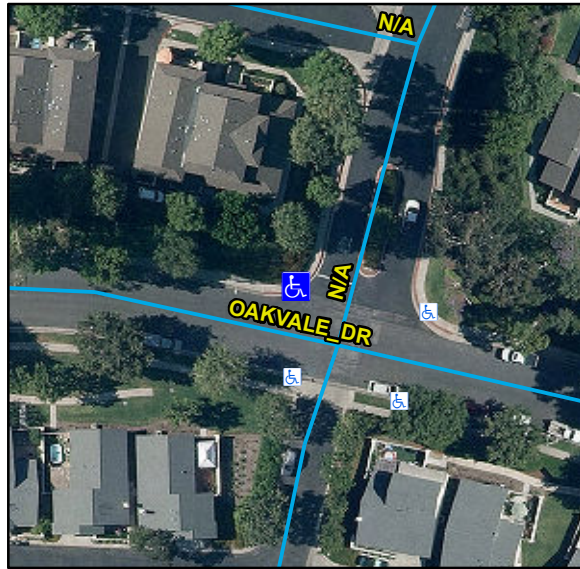
| Compliance | Description | Data | Compliance | Description | Data |
|---|---|---|---|---|---|
| No | Ramp Run Slope (%) | 14.7 | N/A | Flare Slope LT (%) | N/A |
| No | Ramp Cross Slope (%) | 2.6 | N/A | Flare Traversable LT | N/A |

**Remove & Replace Curb Ramp With Two New Directional Ramps or Equivalent.**

**R204.3, R304.2.2, R304.5.3, STD 1115**
