# Access Compliance Report Public Rights-of-Way (Curb Ramps)

Main Street: FAIRLYNN\_BLV D Cross Street: WOODGATE\_DR Location: NE

ADA ID: RPAT210923123126 Ramp Type: Type 4 - Parallel Initial Pass/Fail: Fail Overall Compliance: No Severity Score: 15

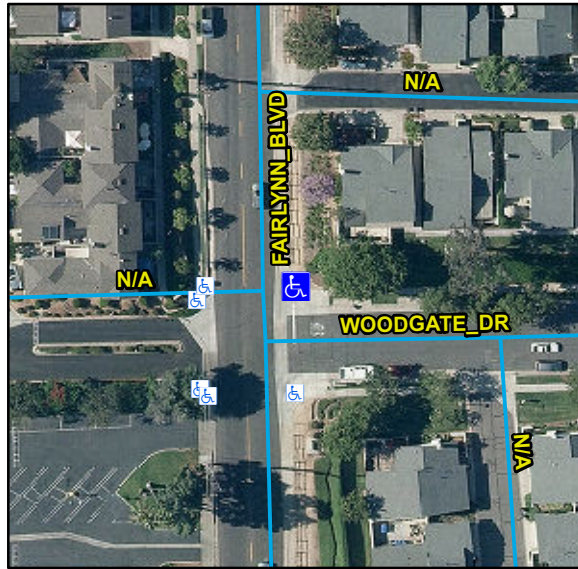
| Compliance | Description | Data | Compliance | Description | Data |
|---|---|---|---|---|---|
| No | Ramp Run Slope LT (%) | 9.7 | Yes | Ramp Run Slope RT (%) | 3.5 |

Remove & Replace Curb Ramp With Two New Directional Ramps or Equivalent.

R304.3.2, STD 1115
