# Access Compliance Report Public Rights-of-Way (Curb Ramps)

Main Street: WOODGATE\_DR Cross Street: FAIRLYNN\_BLVD Location: SE

ADA ID: RPAT210923123630 Ramp Type: Type 4 - Parallel Initial Pass/Fail: Fail Overall Compliance: No Severity Score: 32

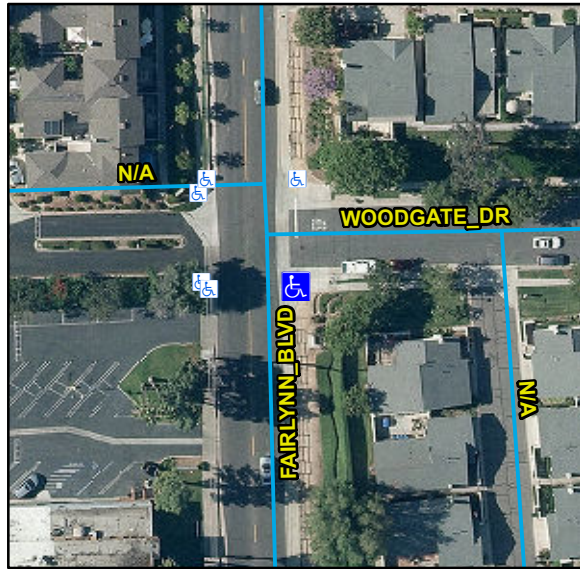
| Compliance | Description | Data | Compliance | Description | Data |
|---|---|---|---|---|---|
| N/A | Ramp Length LT (in) | 82 | N/A | Ramp Length RT (in) | 81 |
| Yes | Ramp Width LT (in) | 73 | Yes | Ramp Width RT (in) | 64 |
| No | Ramp Run Slope LT (%) | 19.7 | Yes | Ramp Run Slope RT (%) | 1.8 |
| No | Ramp Cross Slope LT (%) | 3.3 | Yes | Ramp Cross Slope RT (%) | 1 |

**Remove & Replace Curb Ramp With Two New Directional Ramps or Equivalent.**

**R204.3, R304.3.2, R304.5.3, STD 1115**

Total Cost: \$ 4000

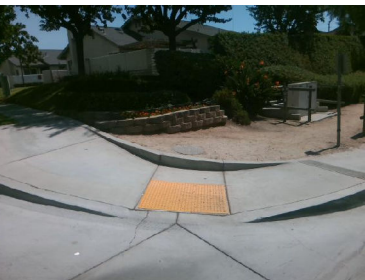
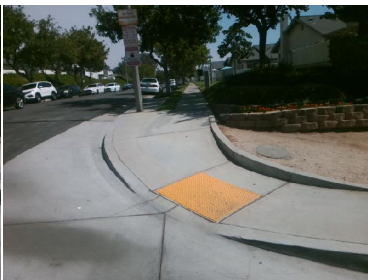
| Compliance | Description | Data | Compliance | Description | Data |
|---|---|---|---|---|---|
| | Crossing 1 Slope (%) | 5.5 | | Crossing 2 Slope (%) | 4.5 |
| | Crossing 1 Cross Slope (%) | 9.3 | | Crossing 2 Cross Slope (%) | 6.5 |
