# Access Compliance Report Public Rights-of-Way (Curb Ramps)

Main Street: N/A Cross Street: FAIRLYNN BLVD Location: NW

ADA ID: RPAT210923124731 Ramp Type: Type 6 - Directional 1 Initial Pass/Fail: Fail Overall Compliance: No Severity Score: 16

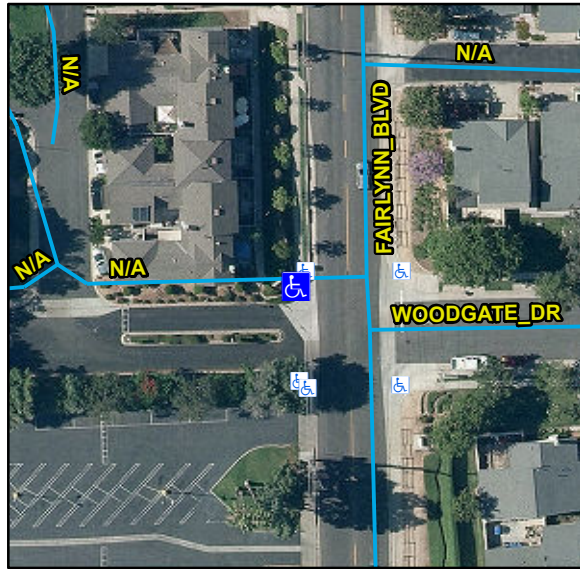
| Compliance | Description | Data | Compliance | Description | Data |
|---|---|---|---|---|---|
| No | Ramp Run Slope (%) | 10.7 | N/A | Flare Slope LT (%) | N/A |

Remove & Replace Entire Ramp.

R304.2.2, STD 1115
