# Access Compliance Report Public Rights-of-Way (Curb Ramps)

Main Street: FAIRLYNN\_BLV D Cross Street: ESPERANZA\_RD Location: NW

ADA ID: RPAT210923125246 Ramp Type: Type 4 - Parallel Initial Pass/Fail: Pass Overall Compliance: No Severity Score: 2

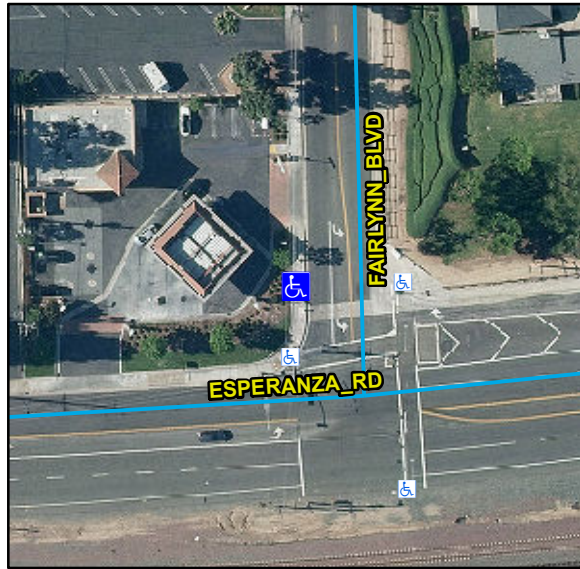
| Compliance | Description | Data | Compliance | Description | Data |
|---|---|---|---|---|---|
| Yes | Ramp Cross Slope LT (%) | 1.6 | No | Ramp Cross Slope RT (%) | 2.4 |

Remove & Replace Entire Ramp.

R304.5.3, STD 1115
