# Access Compliance Report Public Rights-of-Way (Curb Ramps)

Main Street: FAIRLYNN\_BLV Cross Street: ESPERANZA\_RD Location: NE

ADA ID: RPAT210923130057 Ramp Type: Type 1 - Perpendicular Diagonal Initial Pass/Fail: Pass Overall Compliance: No Severity Score: 0

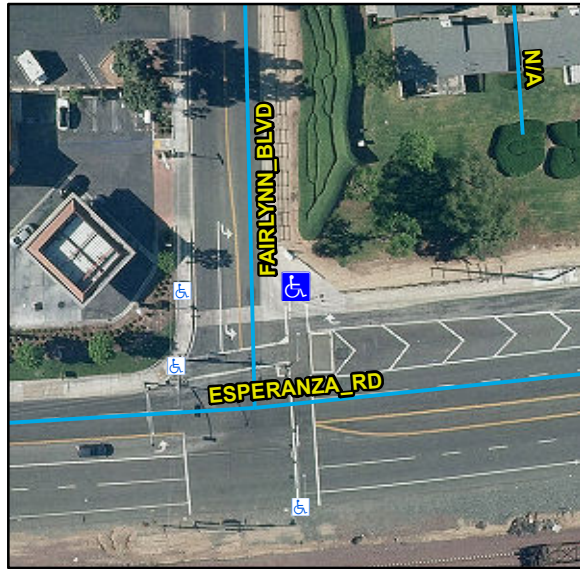
| Compliance | Description | Data | Compliance | Description | Data |
|---|---|---|---|---|---|
| No | Ramp Inside Crosswalk 1 | No | Yes | Ramp Inside Crosswalk 2 | Yes |
| Yes | Gutter Ponding | No | No | Curb Slope | 7.1 |
| No | Gutter Cross Slope (%) | 2.7 | | | |

Remove & Replace Curb Ramp With Two New Directional Ramps or Equivalent. Restripe Crosswalk. Remove & Replace Gutter.

R304.2.2, R304.2.1, R207.1, R304.5.3, STD 1115
