# Access Compliance Report Public Rights-of-Way (Curb Ramps)

Main Street: N/A Cross Street: ESPERANZA\_RD Location: NE

ADA ID: RPAT210923140541 Ramp Type: Type 7 - Directional 2 Initial Pass/Fail: Fail Overall Compliance: No Severity Score: 15

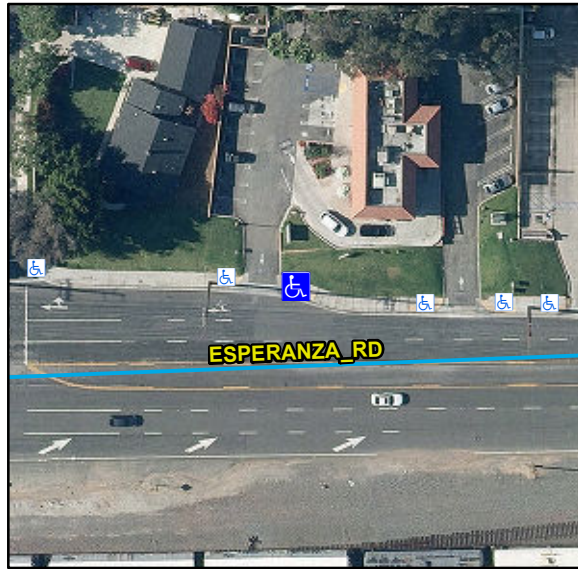
| Compliance | Description | Data | Compliance | Description | Data |
|---|---|---|---|---|---|
| No | Ramp Run Slope (%) | 11 | N/A | Flare Slope LT (%) | N/A |

Remove & Replace Entire Ramp.

R304.2.2, STD 1115
