# Access Compliance Report Public Rights-of-Way (Curb Ramps)

| Main Street: N/A | | Cross Street: ESPERANZA_RD | | Location: | NW |
| ADA ID: RPAT210923141008 | Ramp Type: Type 7 - Directional 2 | Initial Pass/Fail: Fail | Overall Compliance: No | Severity Score: | 15 |

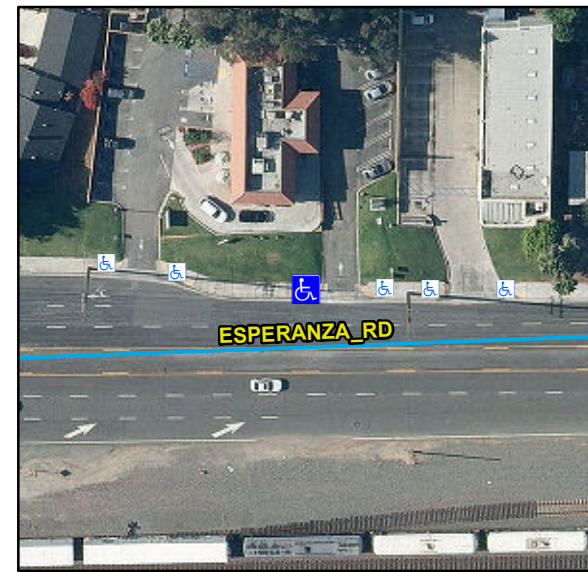
| Compliance | Description | Data | Compliance | Description | Data |
|---|---|---|---|---|---|
| No | Ramp Run Slope (%) | 8.6 | N/A | Flare Slope LT (%) | N/A |

Remove & Replace Entire Ramp.

R304.2.2, STD 1115

\$ 3080

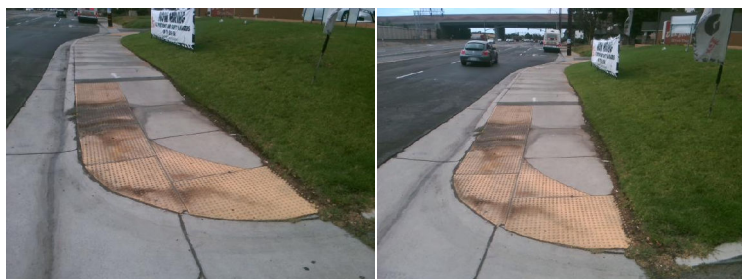
| Compliance | Description | Data | Compliance | Description | Data |
|---|---|---|---|---|---|
| Yes | Ramp Width (in) | 84 | | | N/A |
| Yes | Ramp Cross Slope (%) | 1.3 | N/A | Flare Traversable LT | N/A |
