# Access Compliance Report Public Rights-of-Way (Curb Ramps)

Main Street: N/A Cross Street: ESPERANZA\_RD Location: NE

ADA ID: RPAT210923141316 Ramp Type: Type 7 - Directional 2 Initial Pass/Fail: Fail Overall Compliance: No Severity Score: 15

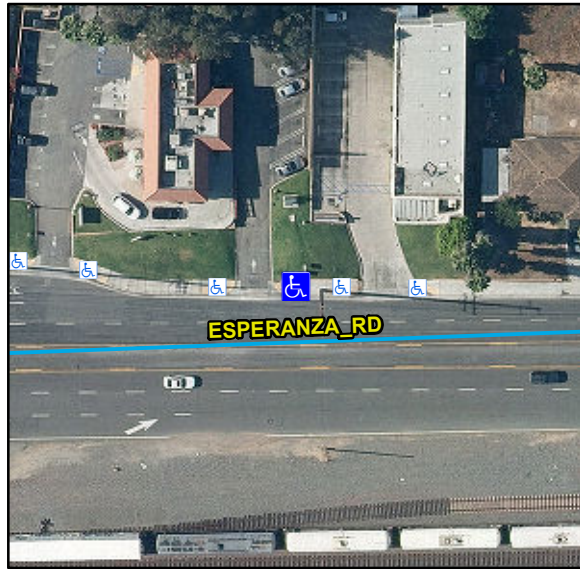
| Compliance | Description | Data | Compliance | Description | Data |
|---|---|---|---|---|---|
| No | Ramp Run Slope (%) | 10.7 | N/A | Flare Slope LT (%) | N/A |

Remove & Replace Entire Ramp.
