# Access Compliance Report Public Rights-of-Way (Curb Ramps)

Main Street: N/A Cross Street: ESPERANZA\_RD Location: NW

ADA ID: RPAT210923141557 Ramp Type: Type 7 - Directional 2 Initial Pass/Fail: Fail Overall Compliance: No Severity Score: 16

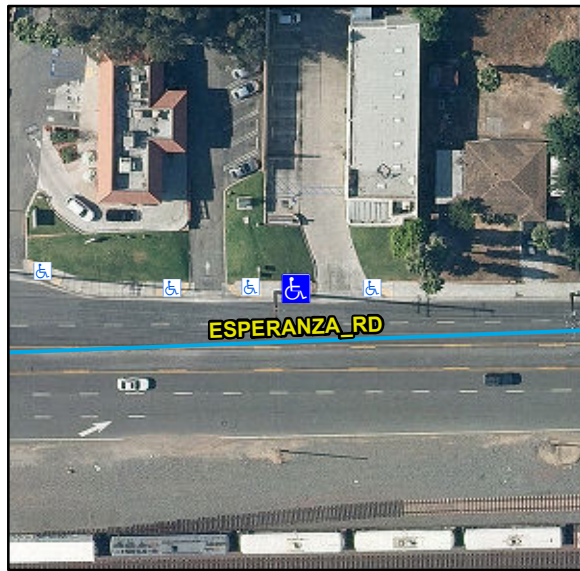
| Compliance | Description | Data | Compliance | Description | Data |
|---|---|---|---|---|---|
| No | Ramp Run Slope (%) | 10.4 | N/A | Flare Slope LT (%) | N/A |
| No | Ramp Cross Slope (%) | 3.7 | N/A | Flare Traversable LT | N/A |

Remove & Replace Entire Ramp.

R304.2.2, R304.5.3, STD 1115
