# Access Compliance Report Public Rights-of-Way (Curb Ramps)

Main Street: N/A Cross Street: ESPERANZA\_RD Location: NE

ADA ID: RPAT210923141840 Ramp Type: Type 7 - Directional 2 Initial Pass/Fail: Fail Overall Compliance: No Severity Score: 45

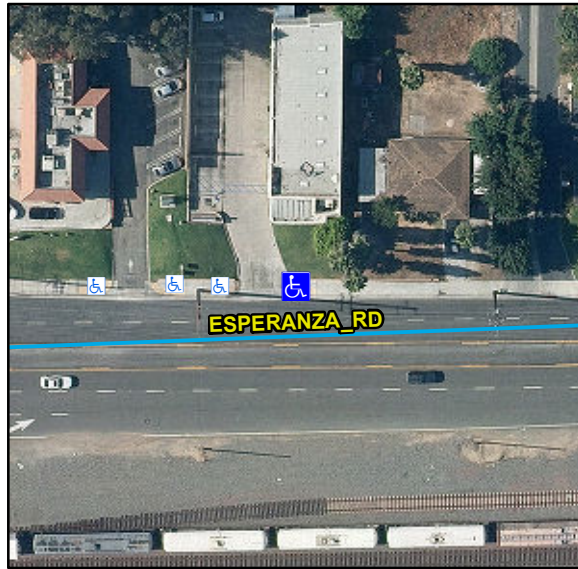
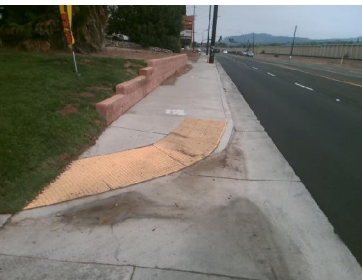
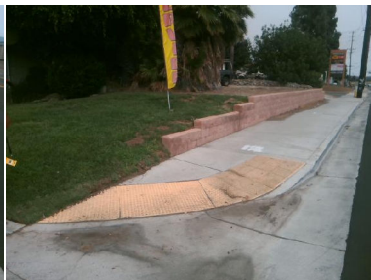
| Compliance | Description | Data | Compliance | Description | Data |
|---|---|---|---|---|---|
| No | Ramp Run Slope (%) | 10.1 | N/A | Flare Slope LT (%) | N/A |
| No | Ramp Cross Slope (%) | 10.7 | N/A | Flare Traversable LT | N/A |

Remove & Replace Entire Ramp.
