# Access Compliance Report Public Rights-of-Way (Curb Ramps)

Main Street: DELL\_ST Cross Street: DUNTON\_AVE Location: SW

ADA ID: RPAT210923152056 Ramp Type: Type 1 - Perpendicular Diagonal Initial Pass/Fail: Pass Overall Compliance: No Severity Score: 2

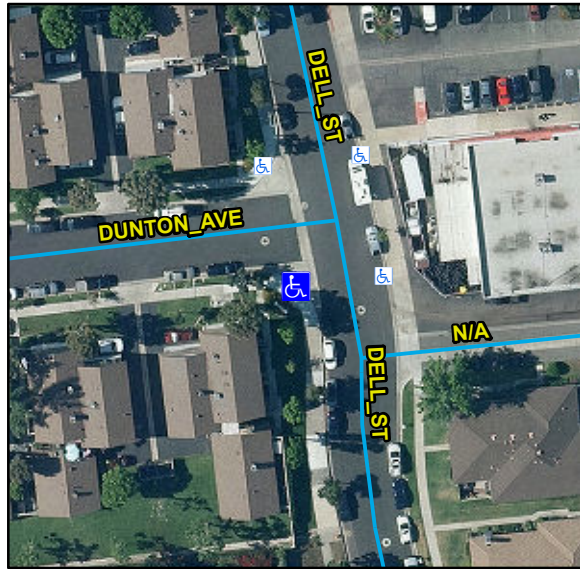
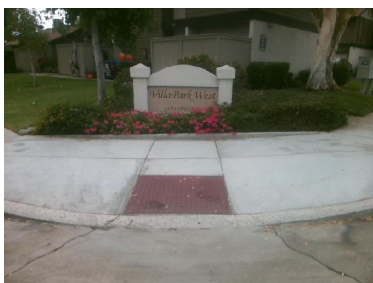
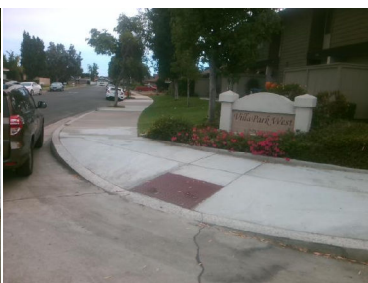
R304.2.2, R304.2.1, R304.5.3, STD 1115

| Compliance | Description | Data | Compliance | Description | Data |
|---|---|---|---|---|---|
| No | Landing Cross Slope (%) | 2.3 | Yes | DWS Provided | Yes |
| Yes | Gutter Ponding | No | No | Curb Slope | 6.9 |

Remove & Replace Curb Ramp With Two New Directional Ramps or Equivalent.
