# Access Compliance Report Public Rights-of-Way (Curb Ramps)

Main Street: DELL\_ST Cross Street: E LINCOLN\_AVE Location: SW

ADA ID: RPAT210924082453 Ramp Type: Type 1 - Perpendicular Diagonal Initial Pass/Fail: Pass Overall Compliance: No Severity Score: 6

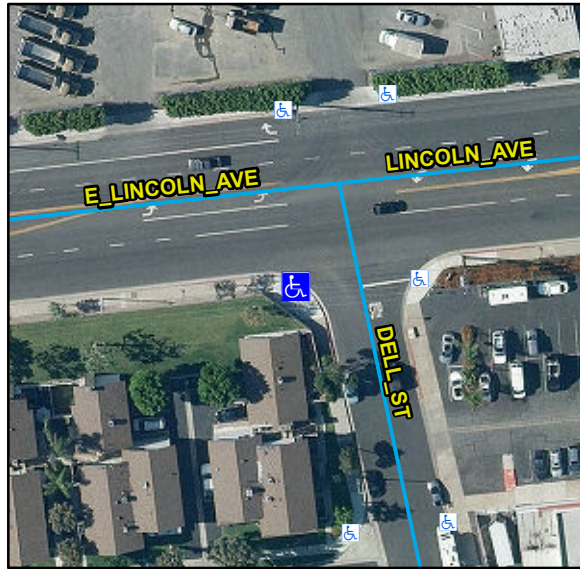
R304.2.2, R304.2.1, STD 1115

| Compliance | Description | Data | Compliance | Description | Data |
|---|---|---|---|---|---|
| Yes | Gutter Ponding | No | No | Curb Slope | 8.4 |

Remove & Replace Curb Ramp With Two New Directional Ramps or Equivalent.
