# Access Compliance Report Public Rights-of-Way (Curb Ramps)

Main Street: LINCOLN\_AVE Cross Street: DELL\_ST Location: SE

ADA ID: RPAT210924083036 Ramp Type: Type 1 - Perpendicular Diagonal Initial Pass/Fail: Fail Overall Compliance: No Severity Score: 2

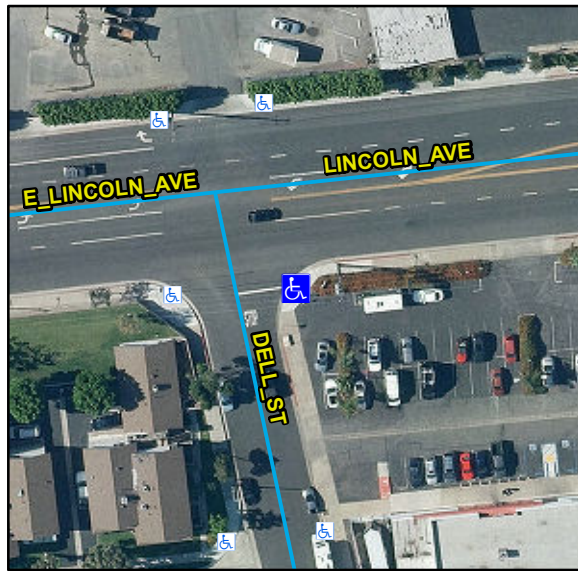
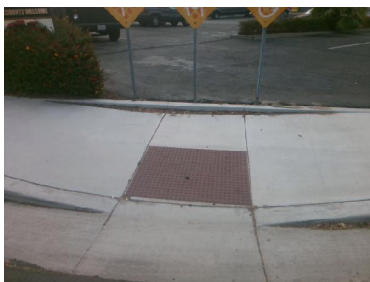
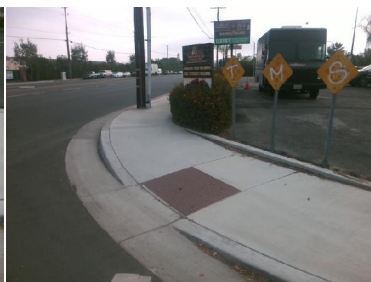
Remove & Replace Curb Ramp With Two New Directional Ramps or Equivalent.

| Compliance | Description | Data | Compliance | Description | Data |
|---|---|---|---|---|---|
| No | Ramp Cross Slope (%) | 2.6 | N/A | Flare Traversable LT | N/A |

R304.5.3, STD 1115
